RE: Golden State Metals
EPA ID Number CAD982489809

ABBREVIATED PRELIMINARY ASSESSMENT REPORT

Site Information: Golden State Metals
2000 East Brundage Lane
Bakersfield, CA 93387
Latitude 35° 21' 18" Longitude 118° 58' 08"

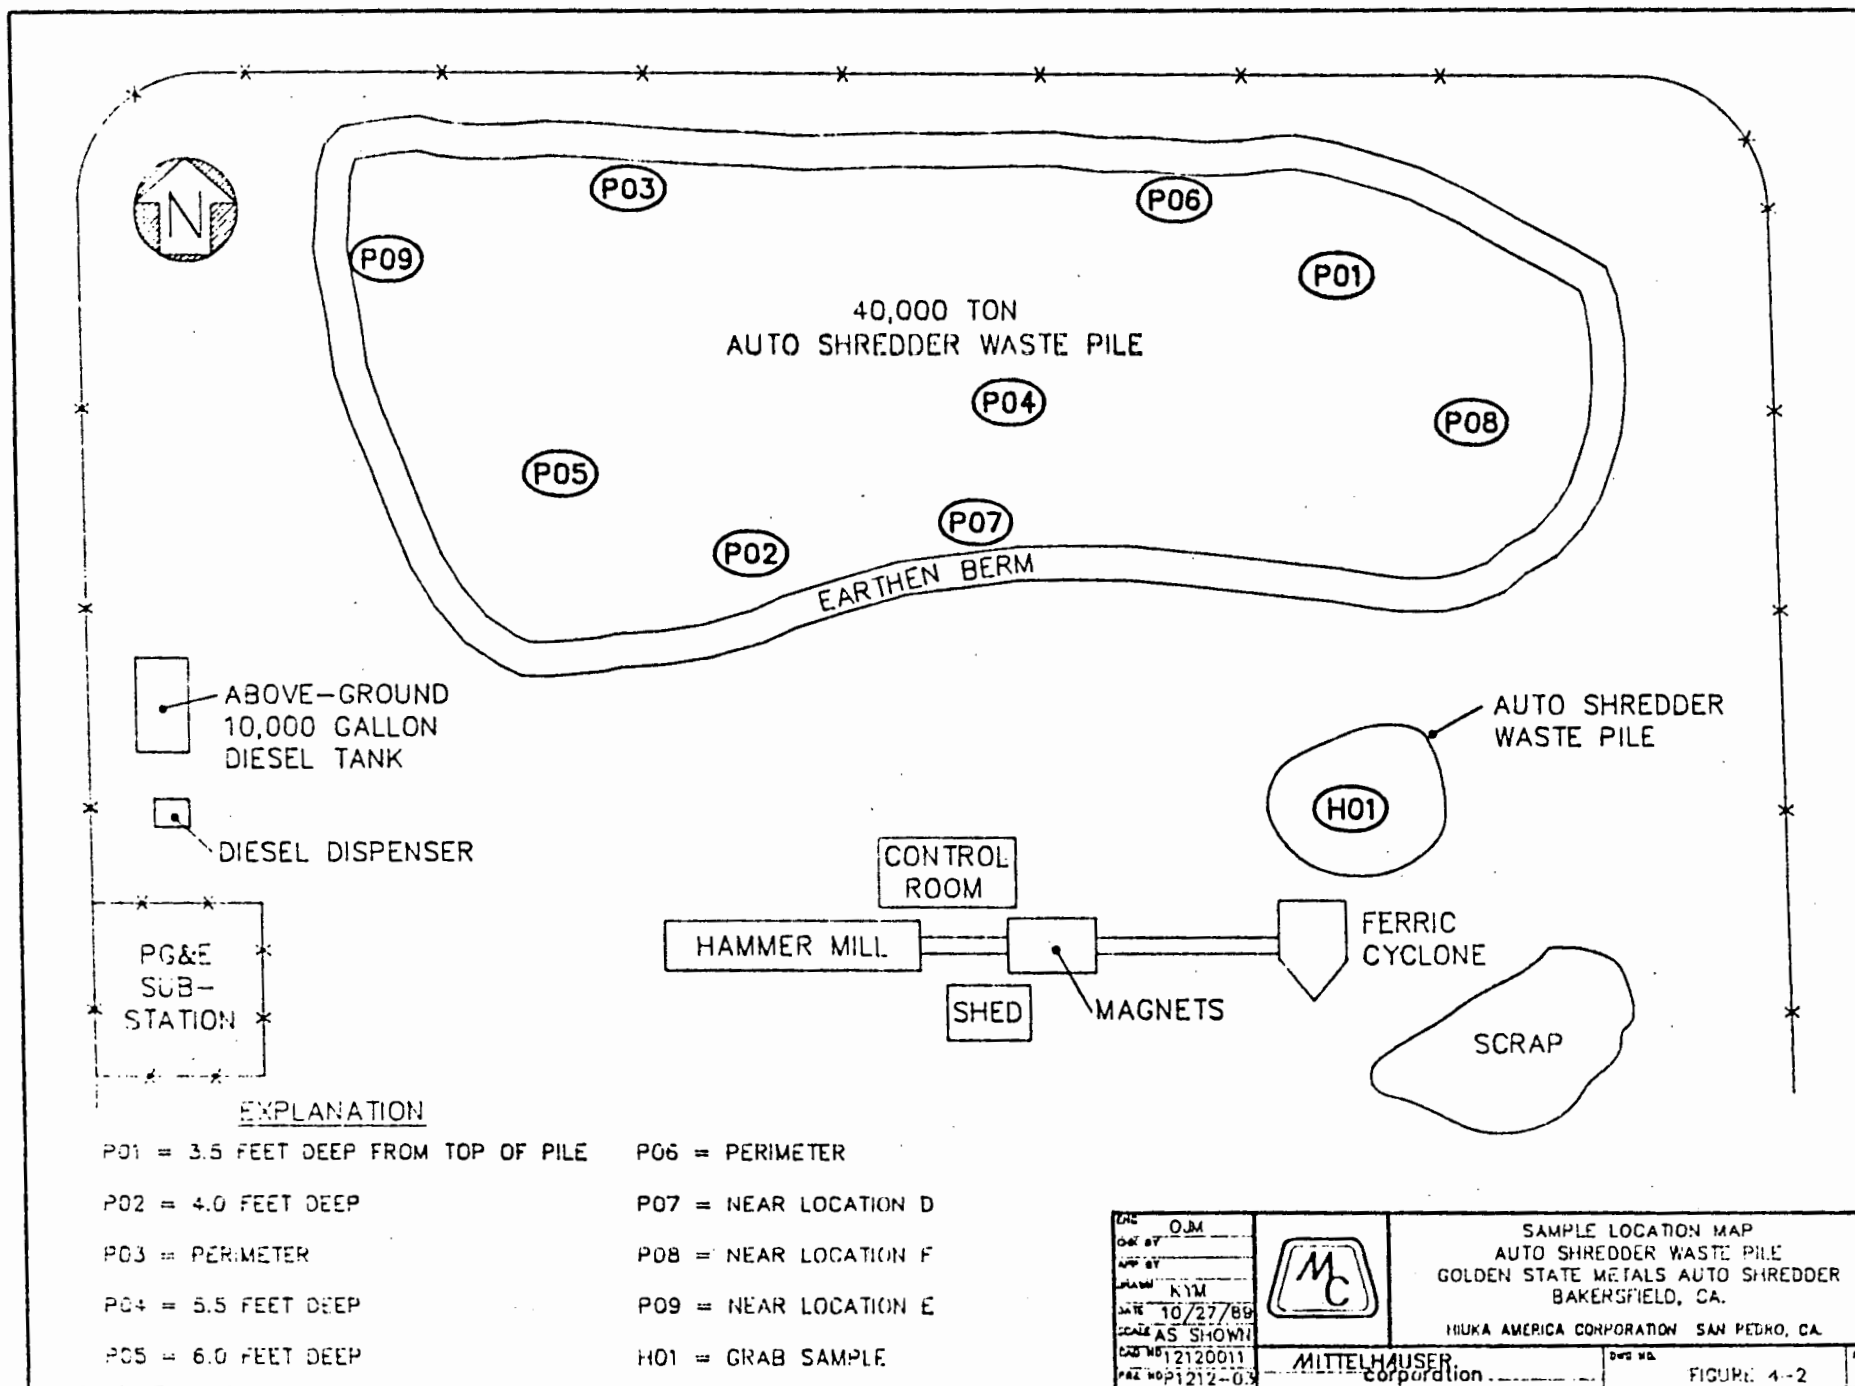
Seven borings were drilled onsite to assess subsurface conditions. These areas are identified as Sample Locations A through G on Figure 4.1. Surficial sampling was concentrated at the auto shredder waste piles, where both Figures 4-1 and 4-2 present the location of the sampled areas.

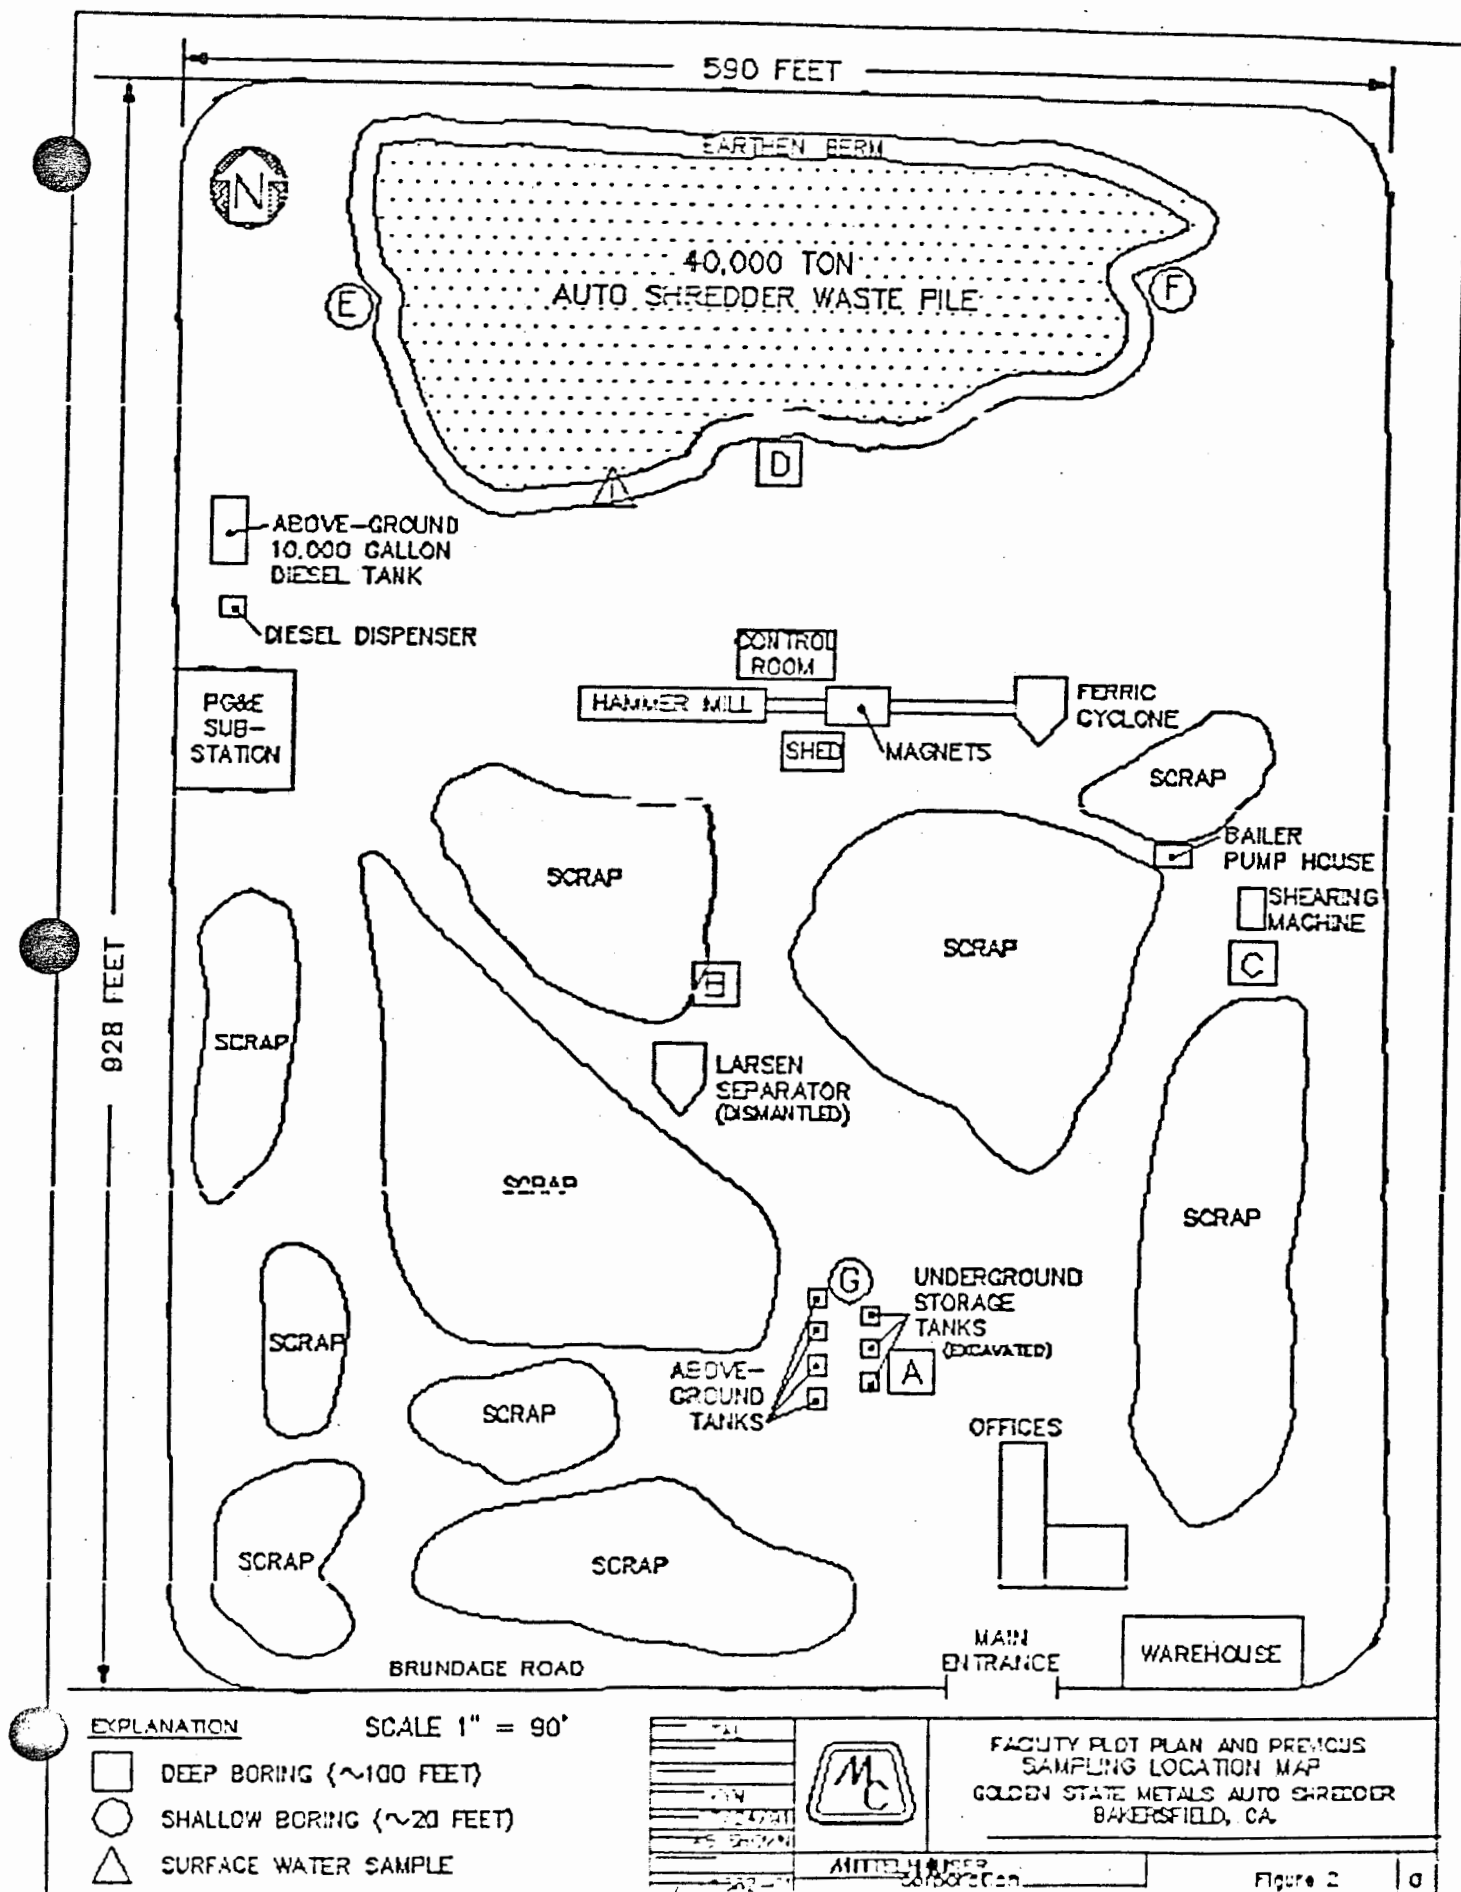
Figure 2 shows the approximate layout of the GSM facility. The northern third of the site is occupied by a pile of auto shredder waste approximately 75,000 cubic yards in volume. One hundred feet south of the pile is the auto shredder which consists of a hammer mill, magnetic separator, ferrous and non-ferrous Z-box separators, and ferrous and non-ferrous cyclone separators. A Larsen separator existed near the center of the property, but it was dismantled in 1990. The boiler pump house and shearing machine are located approximately 100 feet southeast of the auto shredder. Three 300-gallon and one 100-gallon above-ground fuel storage tanks are located in the south central part of the facility. Three underground fuel storage tanks existed next to the above-ground tanks, but the former were removed in March 1990. A 10,000-gallon

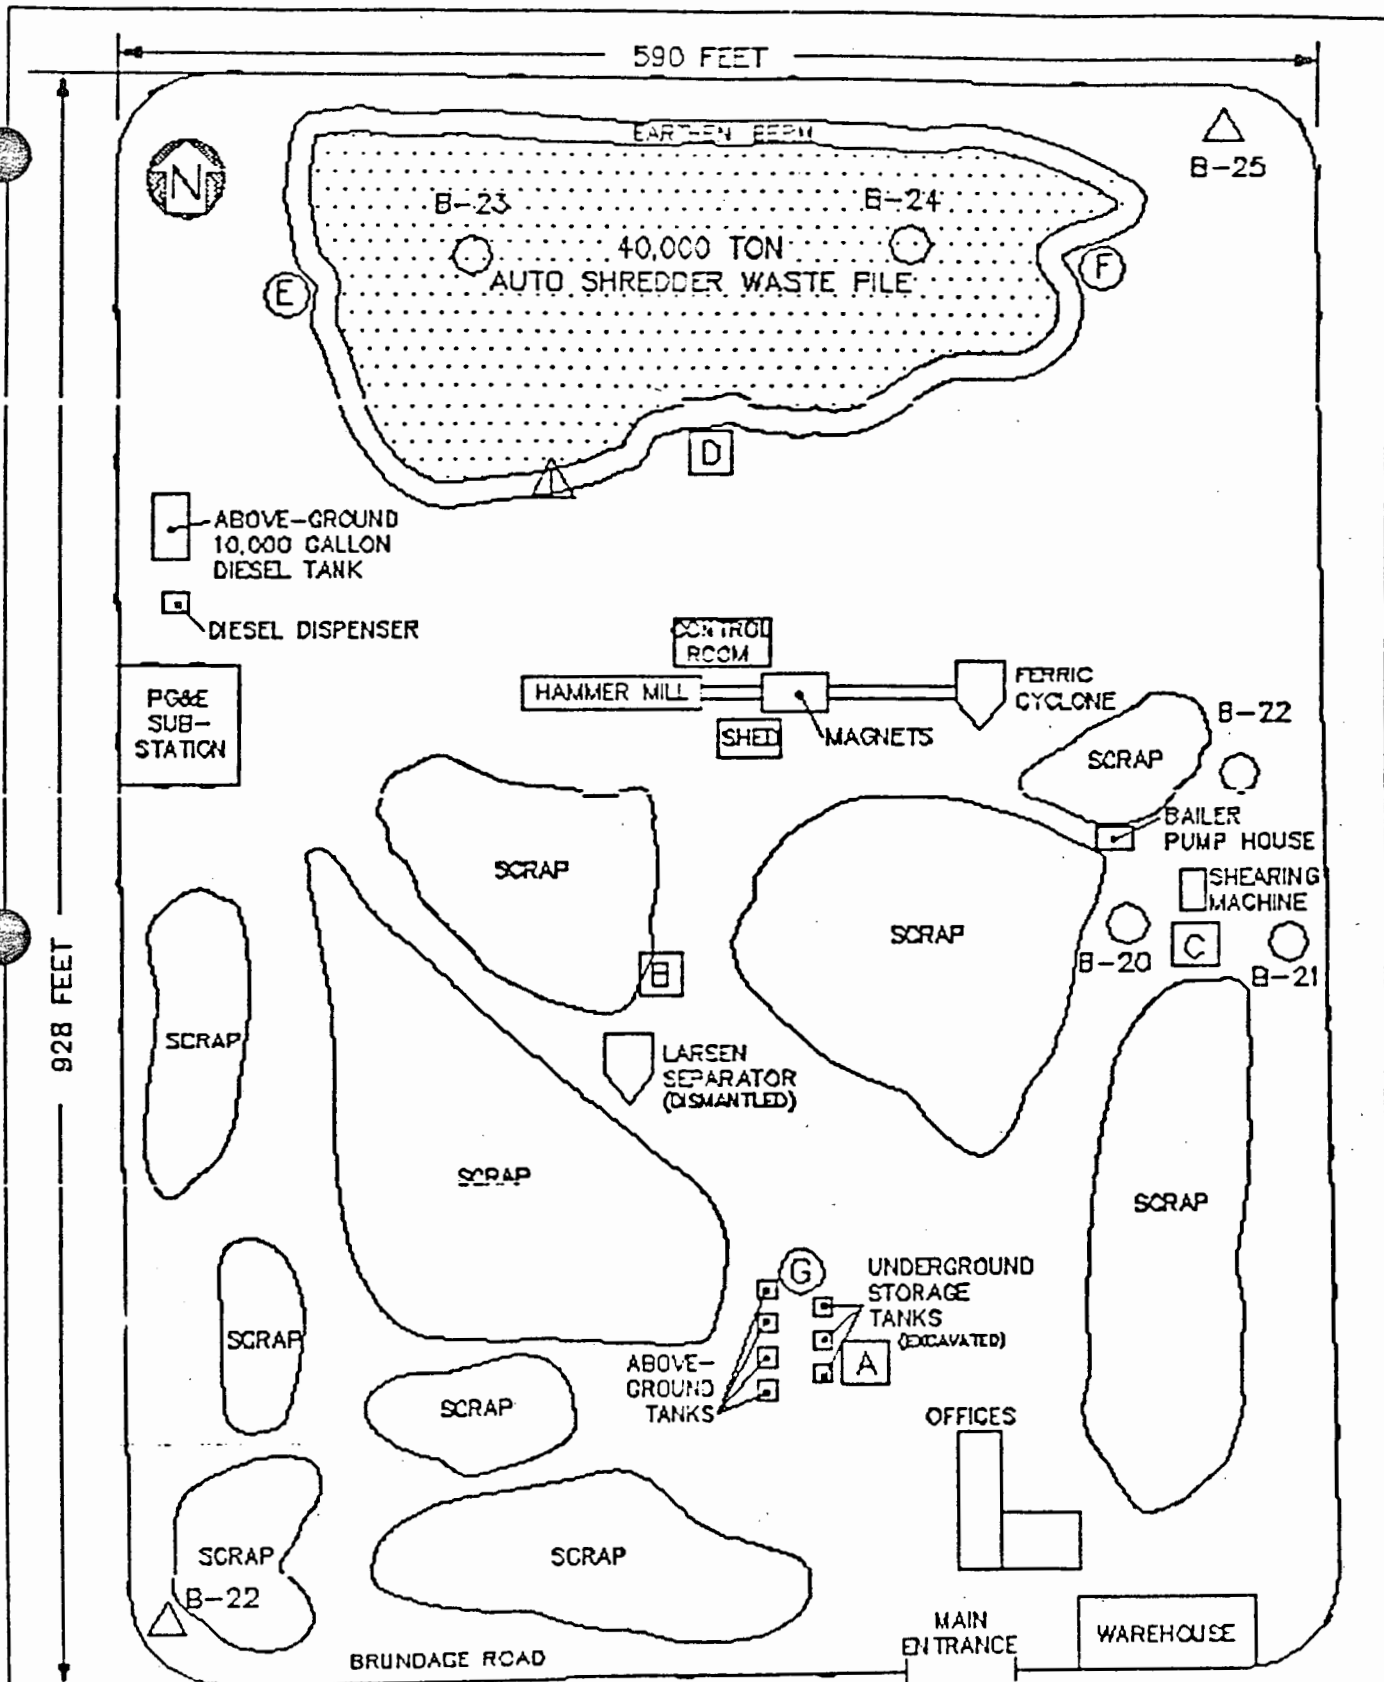
A total of 7 borings are planned for the investigation. The locations of proposed Borings B20 through B26 are shown in Figure 4. Two borings will be drilled to the depth of 50 feet in the footprint area of the auto shredder waste pile and three borings to the depth of 40 feet in the area of the shearing machine.
